PERATION

GREENHOUSE

SCIENTIFIC DIRECTOR'S REPORT

ANNEX 3.2 U. S. NAVY STRUCTURES

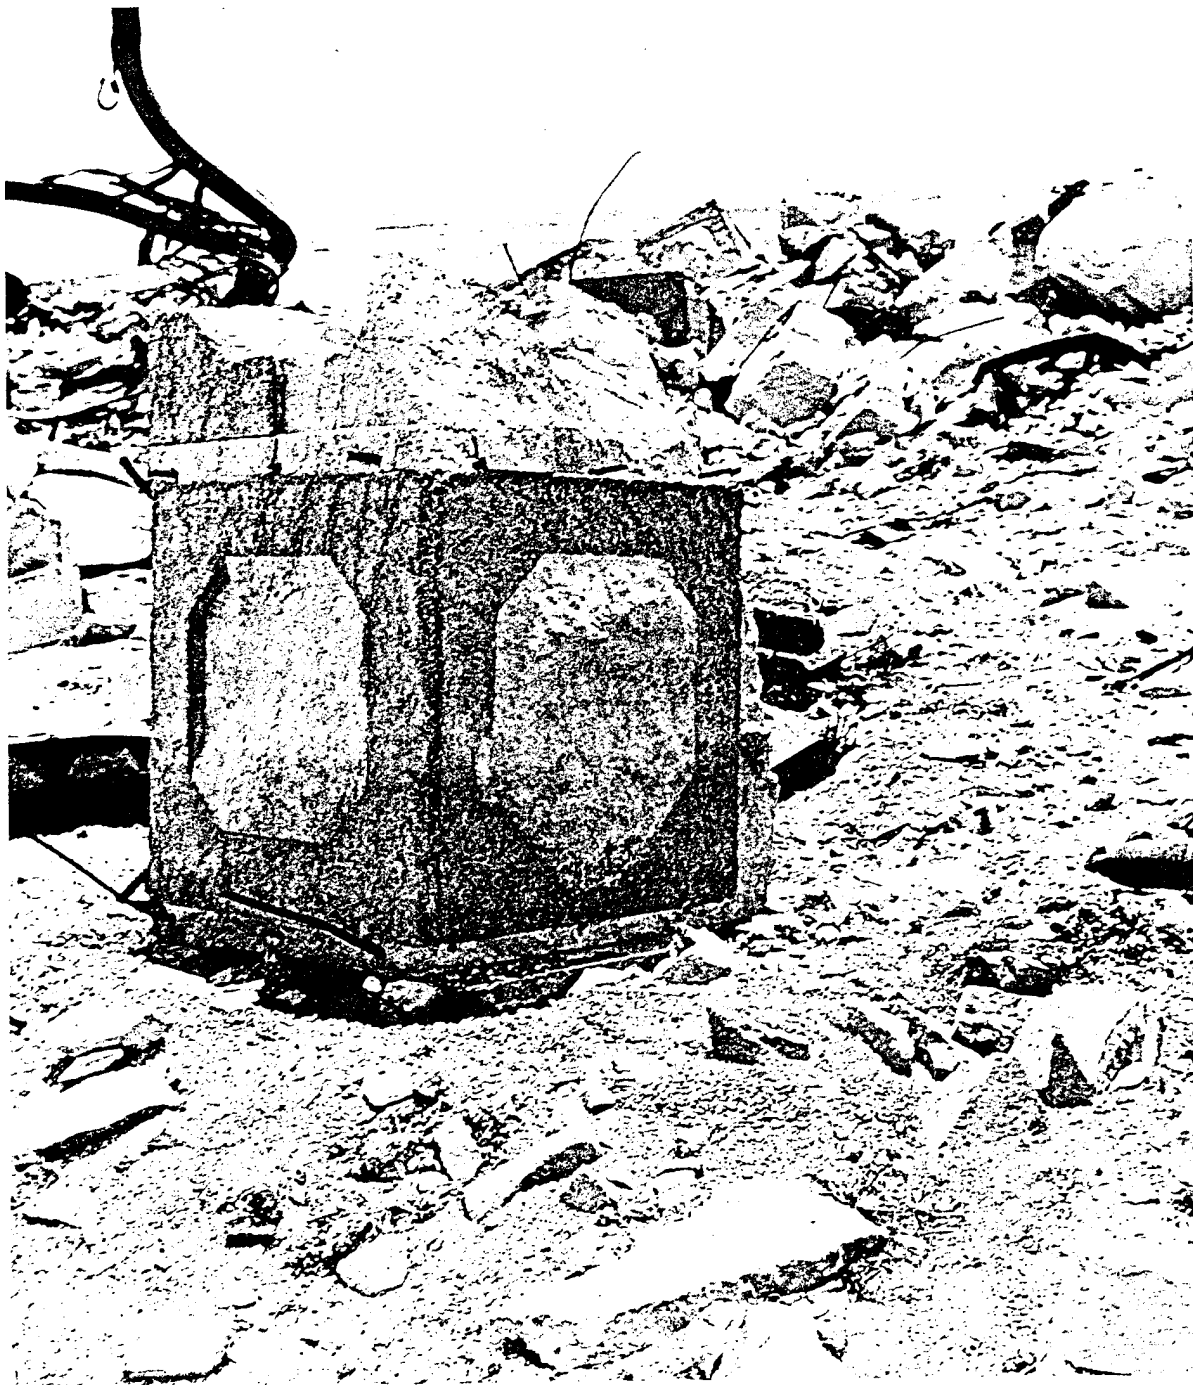
Fig. L.42 Filled Cells from Left Edge of Slab, Structure 3.2.1b. Bottom steel plate has weld failures where separation from left bearing wall occurred.

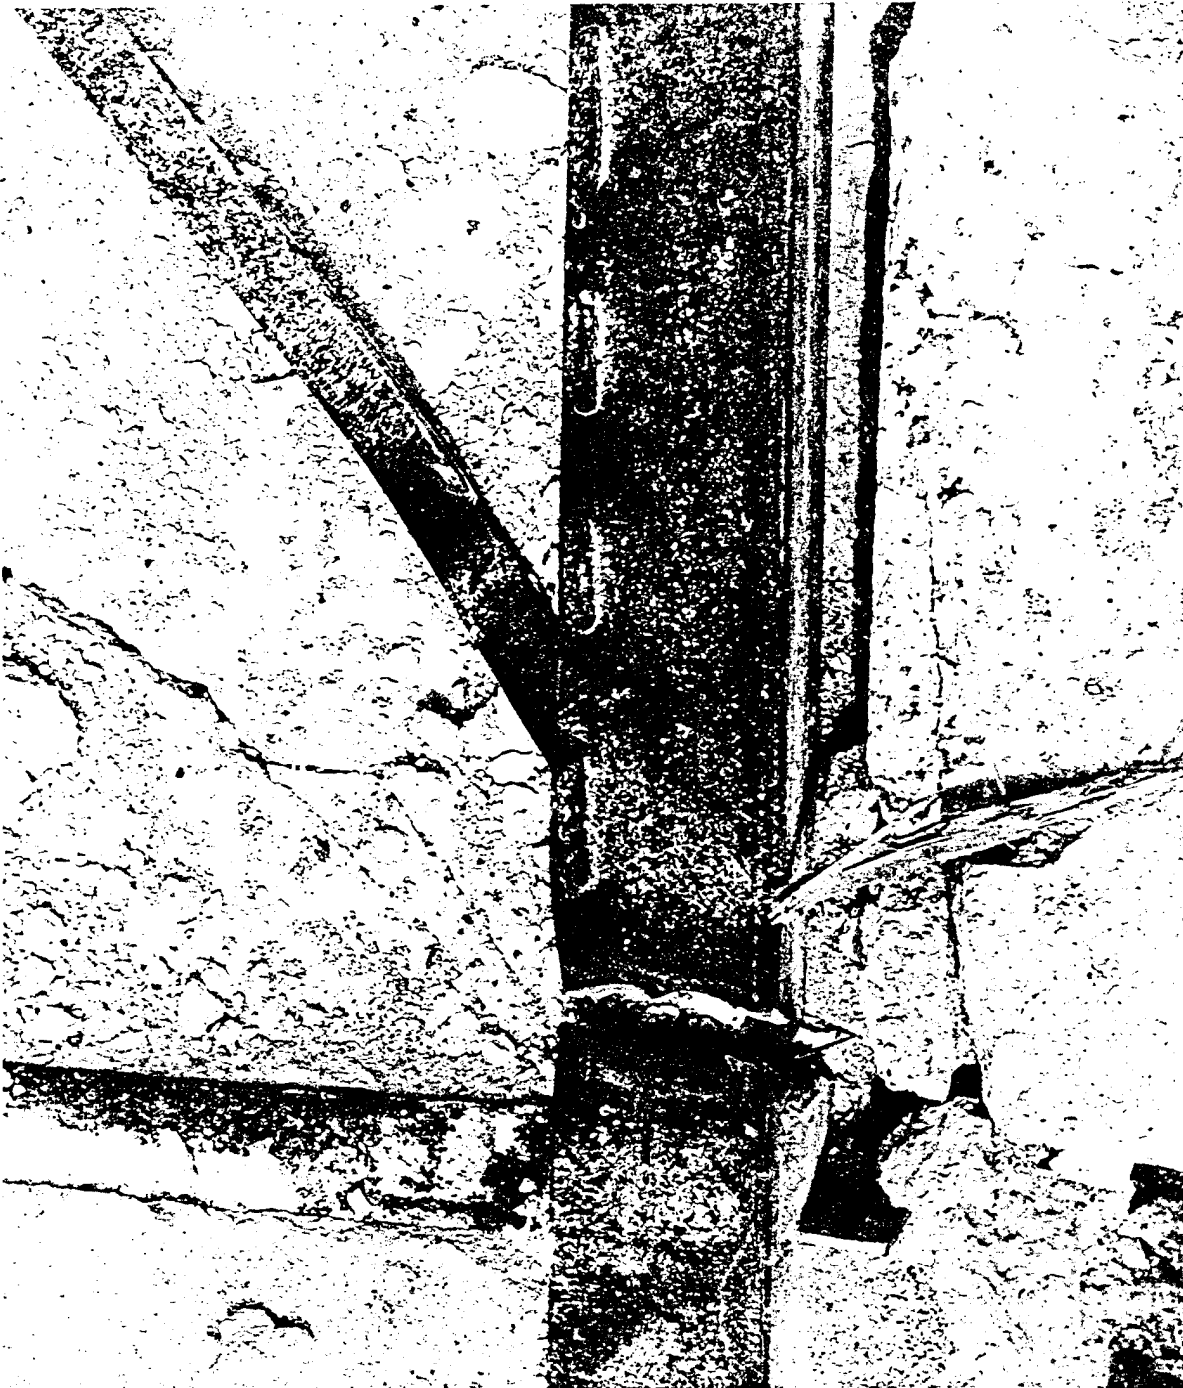
Fig. L.46 Welding Failures Where Truss in Slab Separated from Angle on Bearing Wall, Structure 3.2.1b

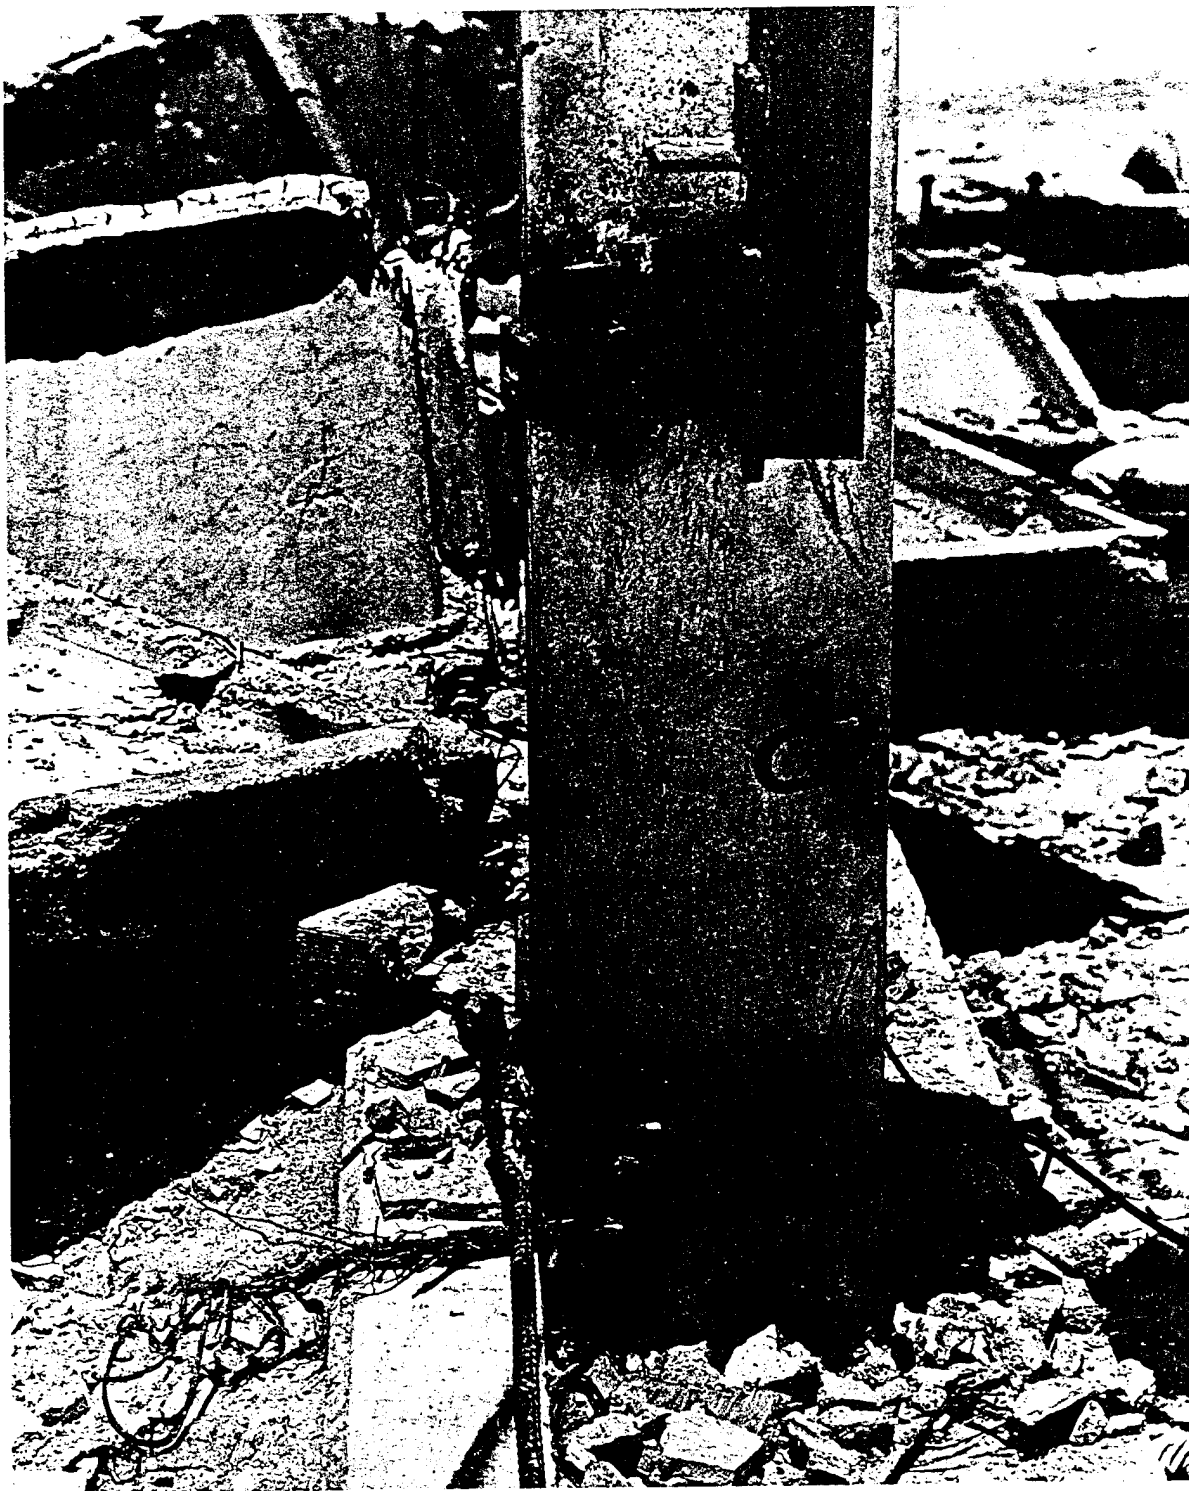
Fig. L.77 Rear Column of Center Bent, Structure 3.2.2a. Note anchor plates from rear panels bent inward, indicating inward pressure prior to front-wall failure.

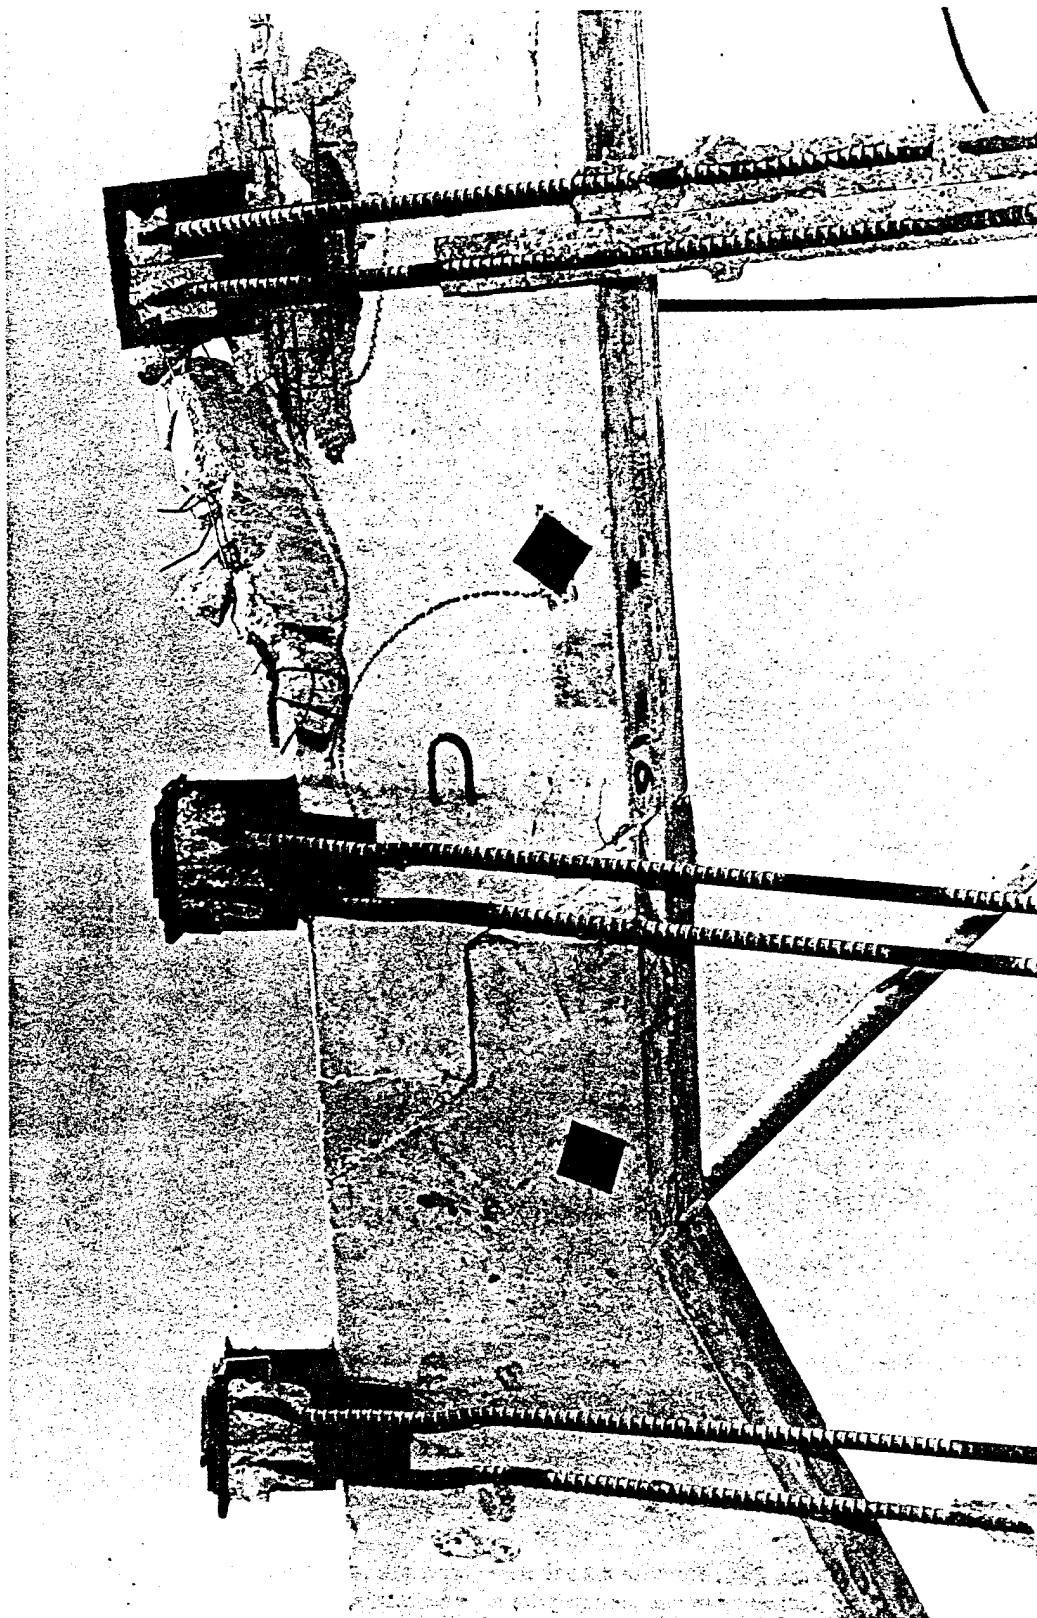
Fig. L.78 Front Panel Connection Failure Showing Separation of Plate from Panel and Bolt Elongation, Structure 3.2.2a. Note shear reinforcement at grout hole consisting of angles and dry-pack in grout hole.

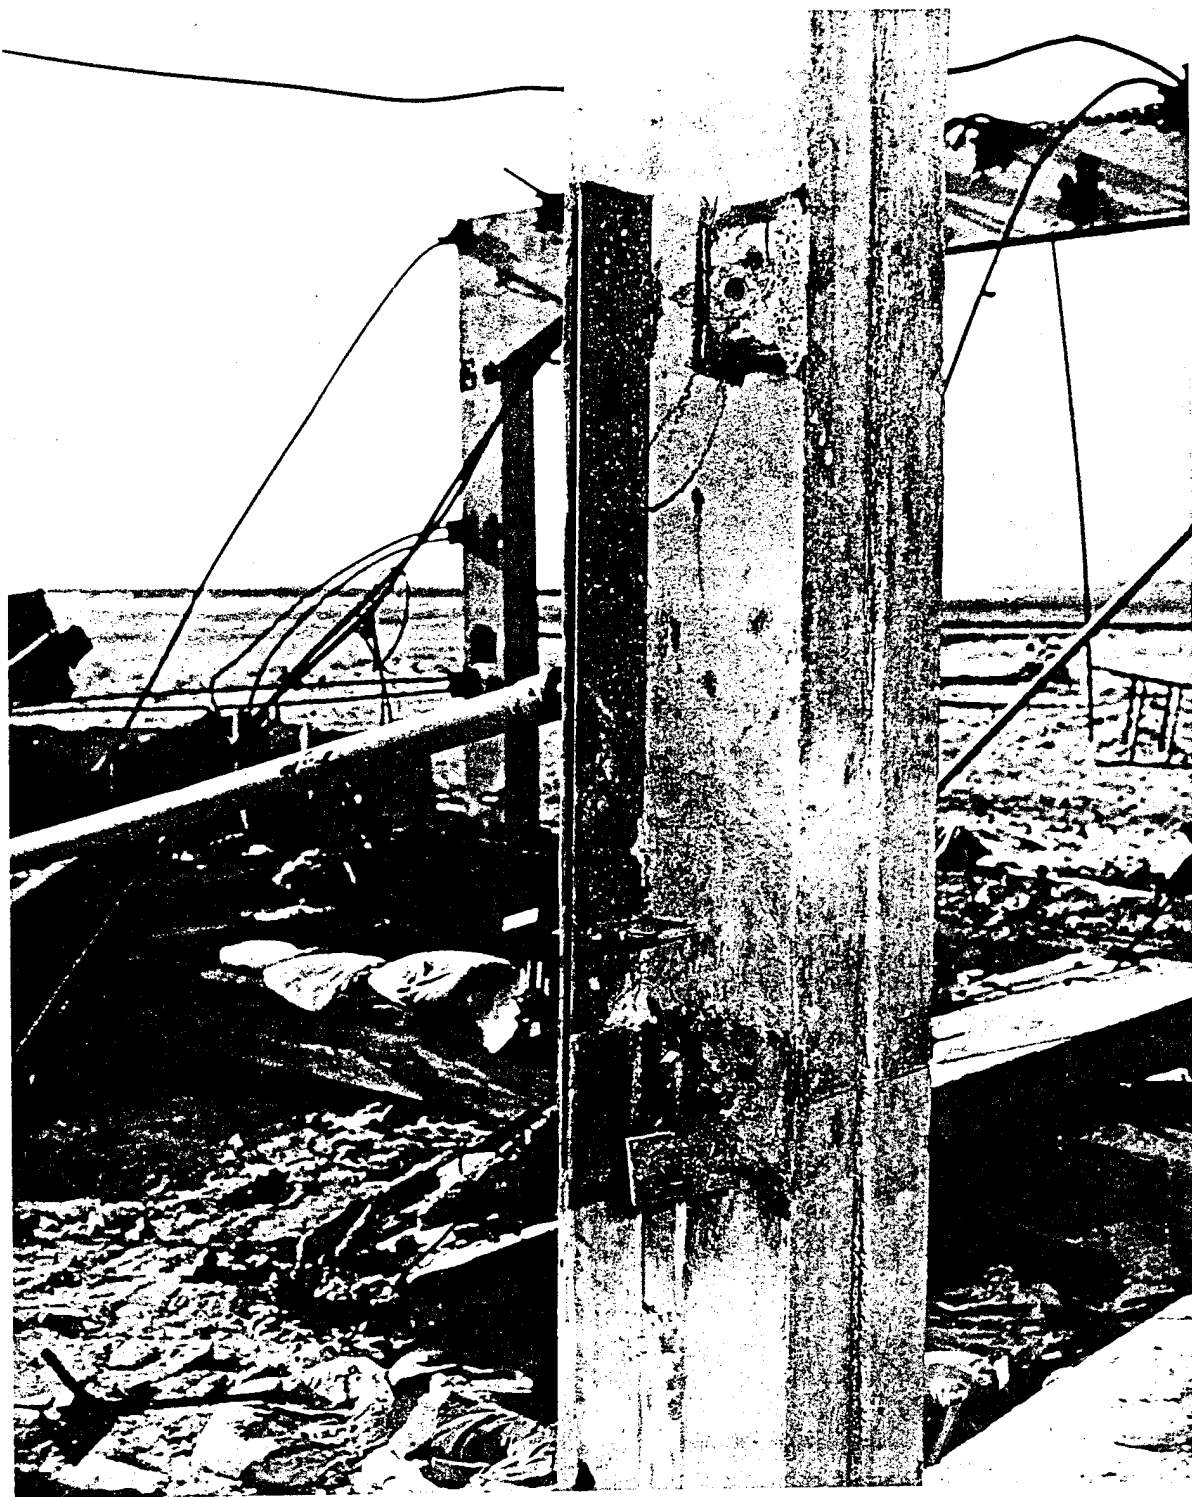
Fig. L.81 Steel from Right Side-wall Panels Which Remained Attached When Panels Blew Out, Structure 3.2.2a

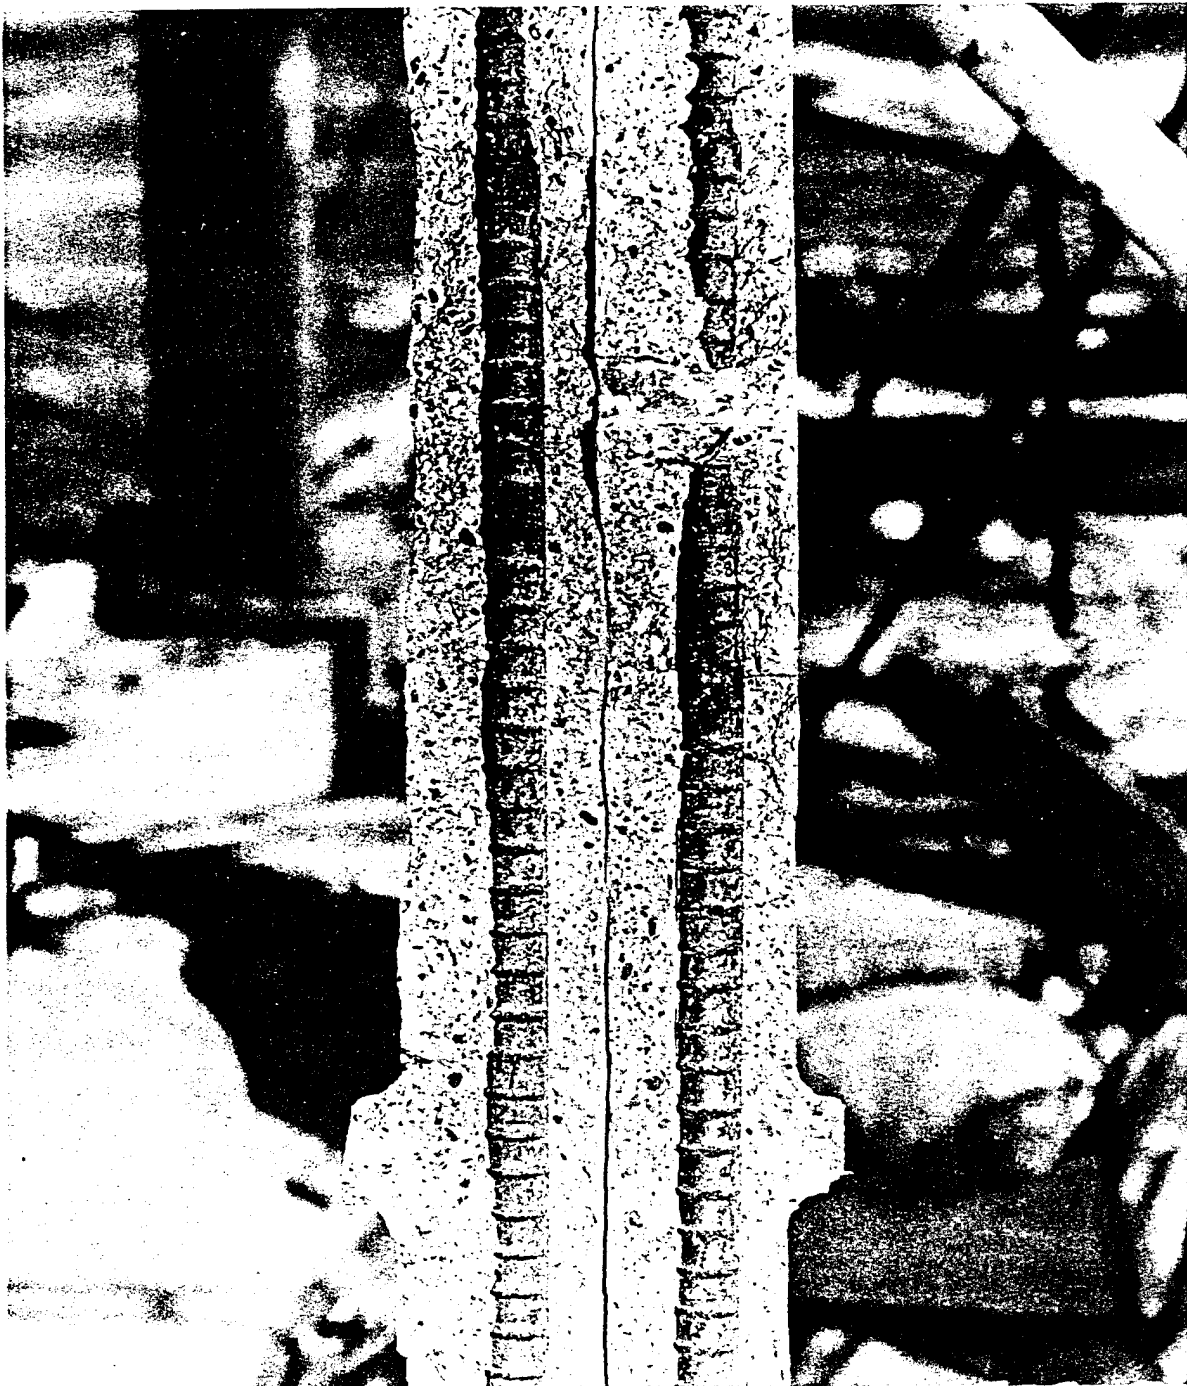
Fig. L.82 Failure of Concrete in Tension in Rib of Right Side Panel, Structure 3.2.2a

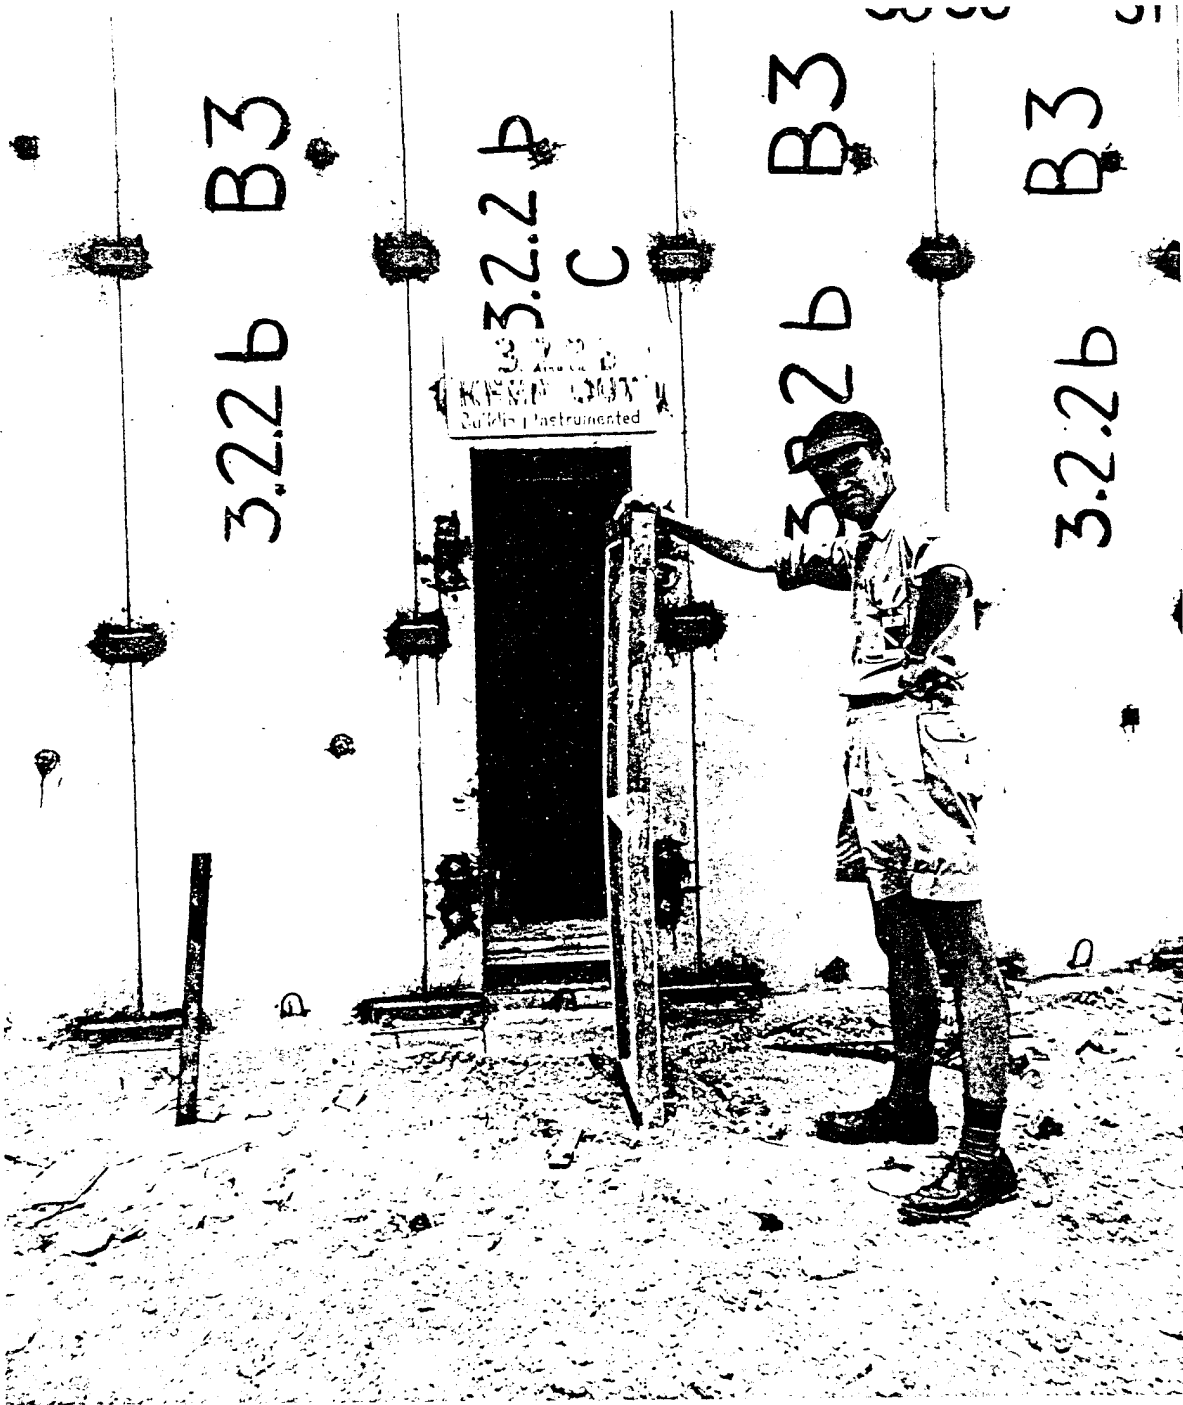
Fig. L.112 Door Showing 1½-in. Deformation, Structure 3.2.2b. Note burned black letters on sign.

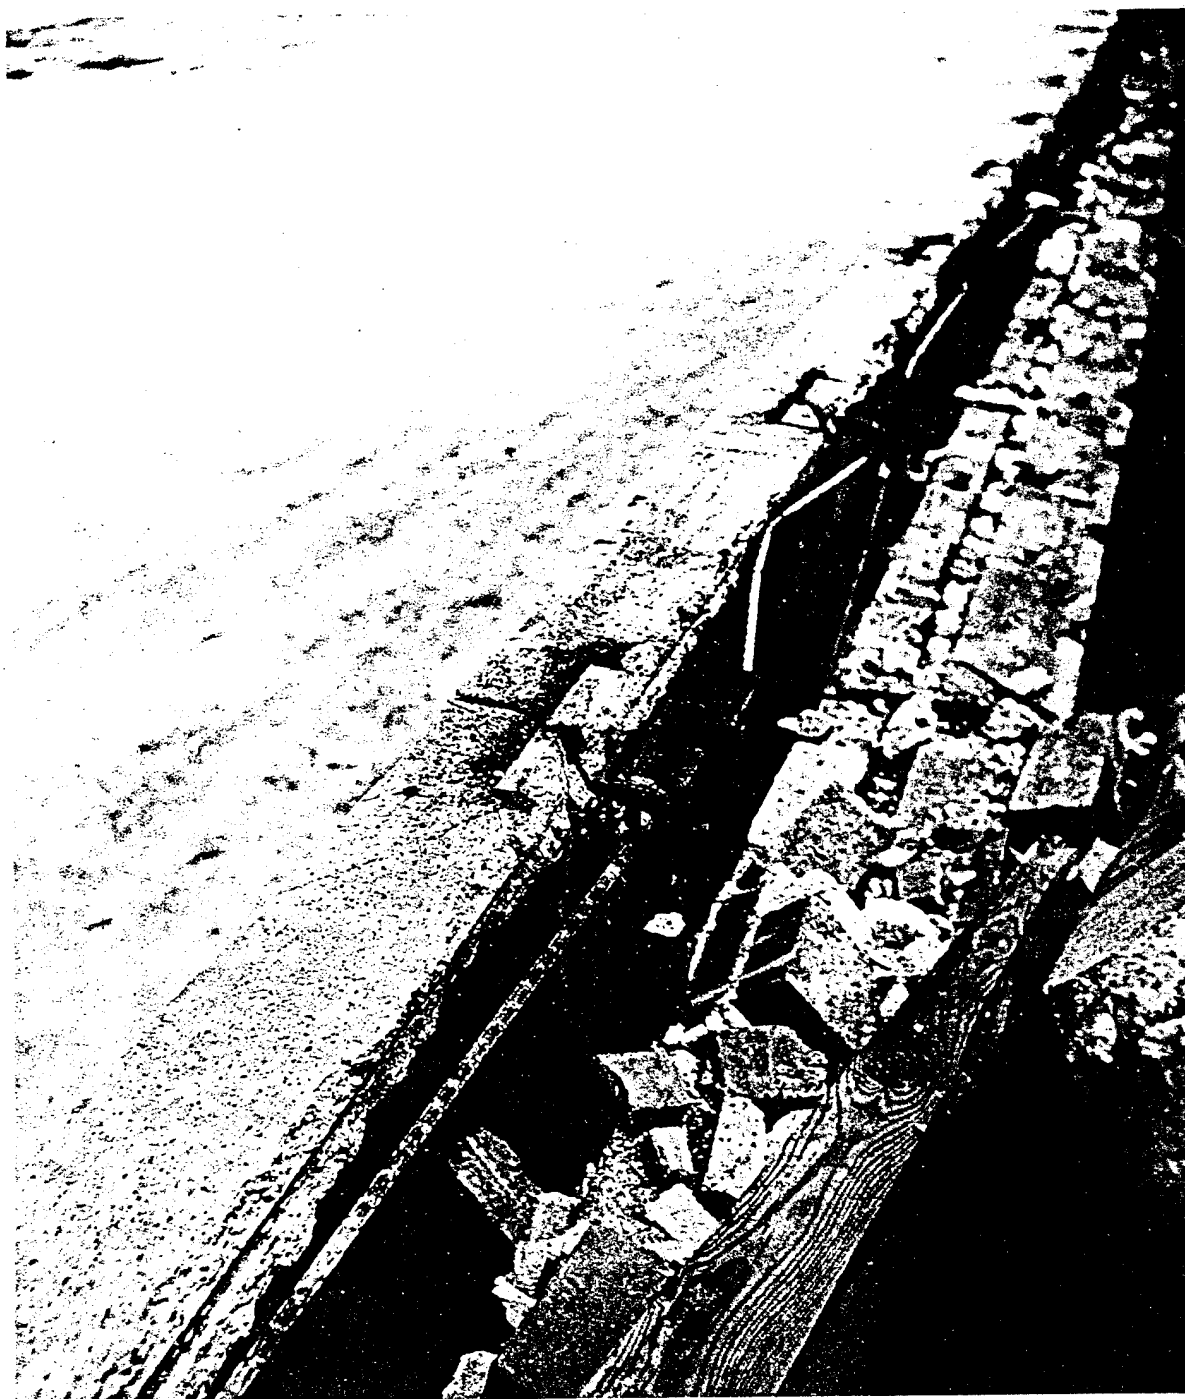
Fig. L.122 Close-up of Welding Failure at Connection Between Rear Panel and Roof Panel, Structure 3.2.2b

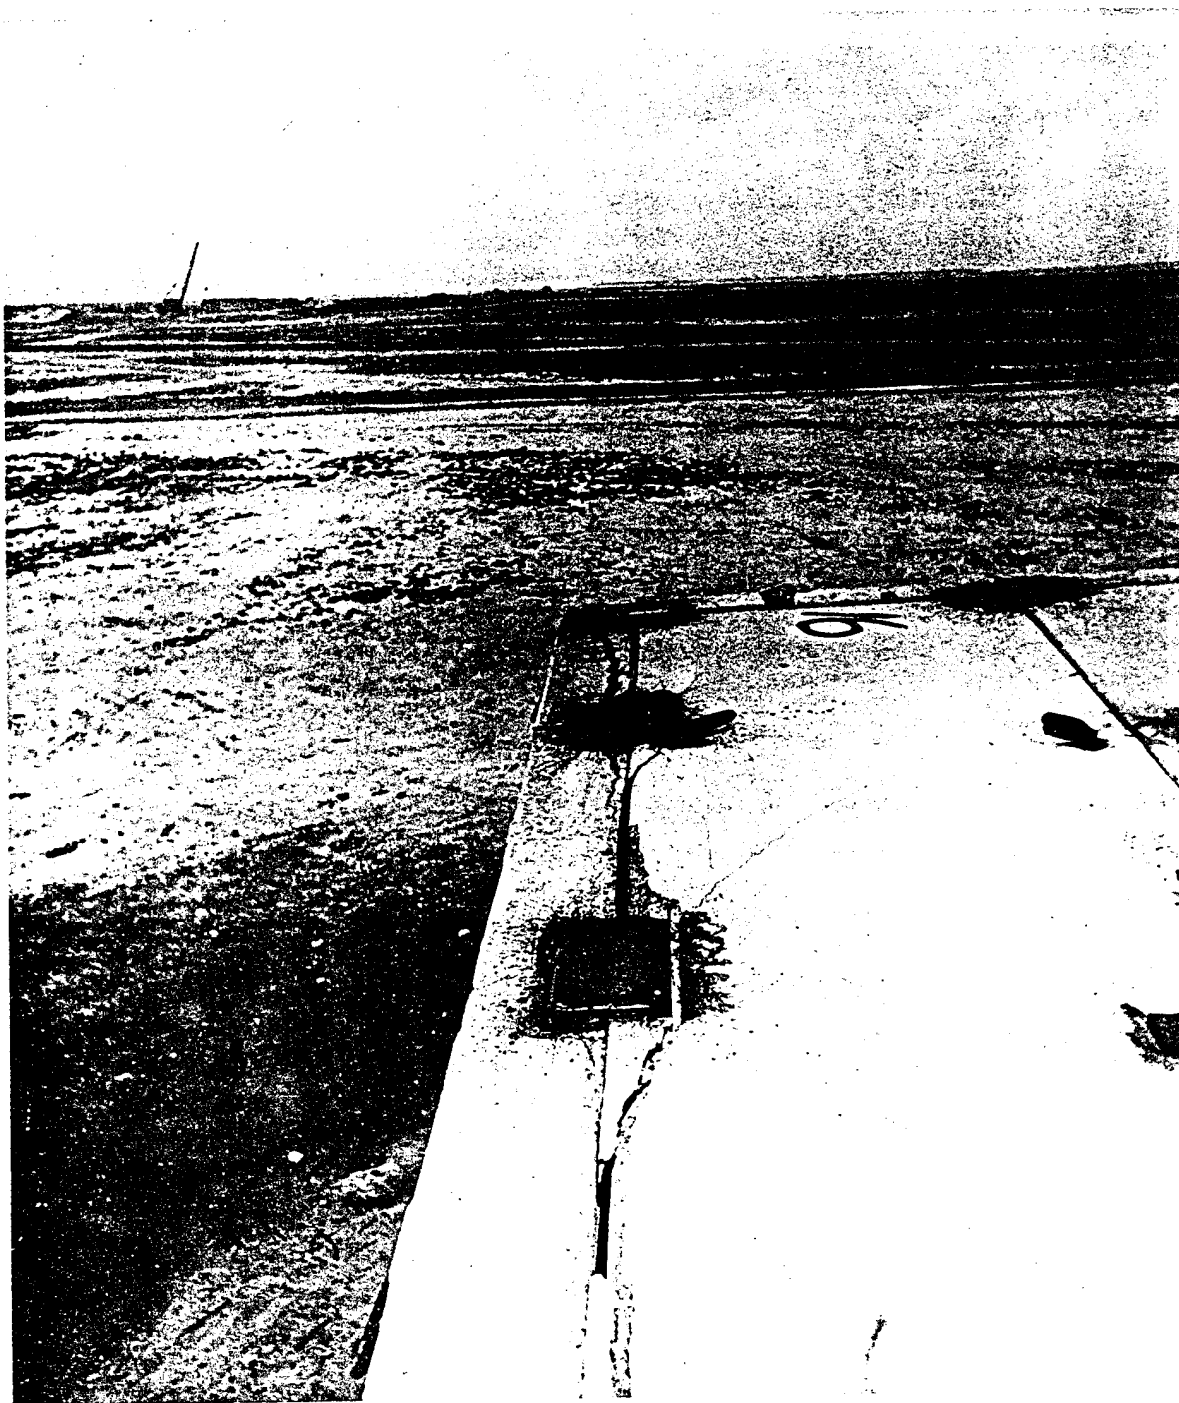
Fig. L.125 Atop Right Side Looking toward Front, Structure 3.2.2b. Note cracks at splice plates.

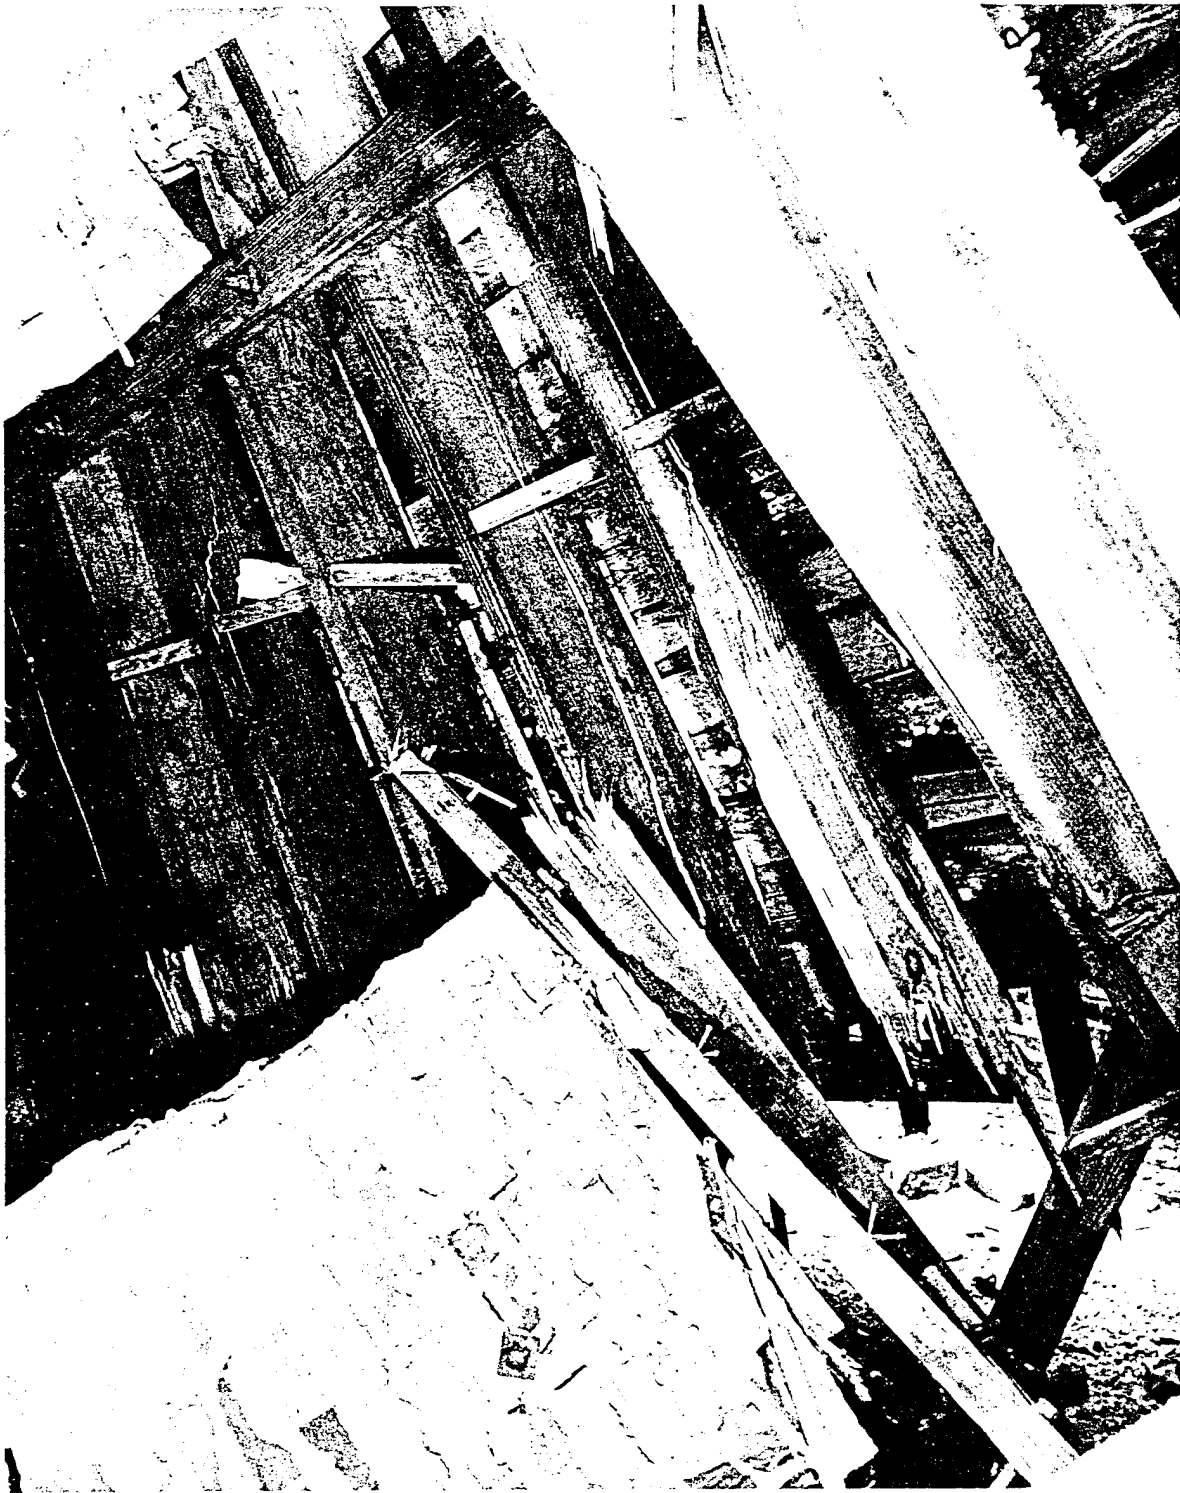
Fig. L.144 Interior View Showing Fractured Roof Joists, Structure 3.2.2b

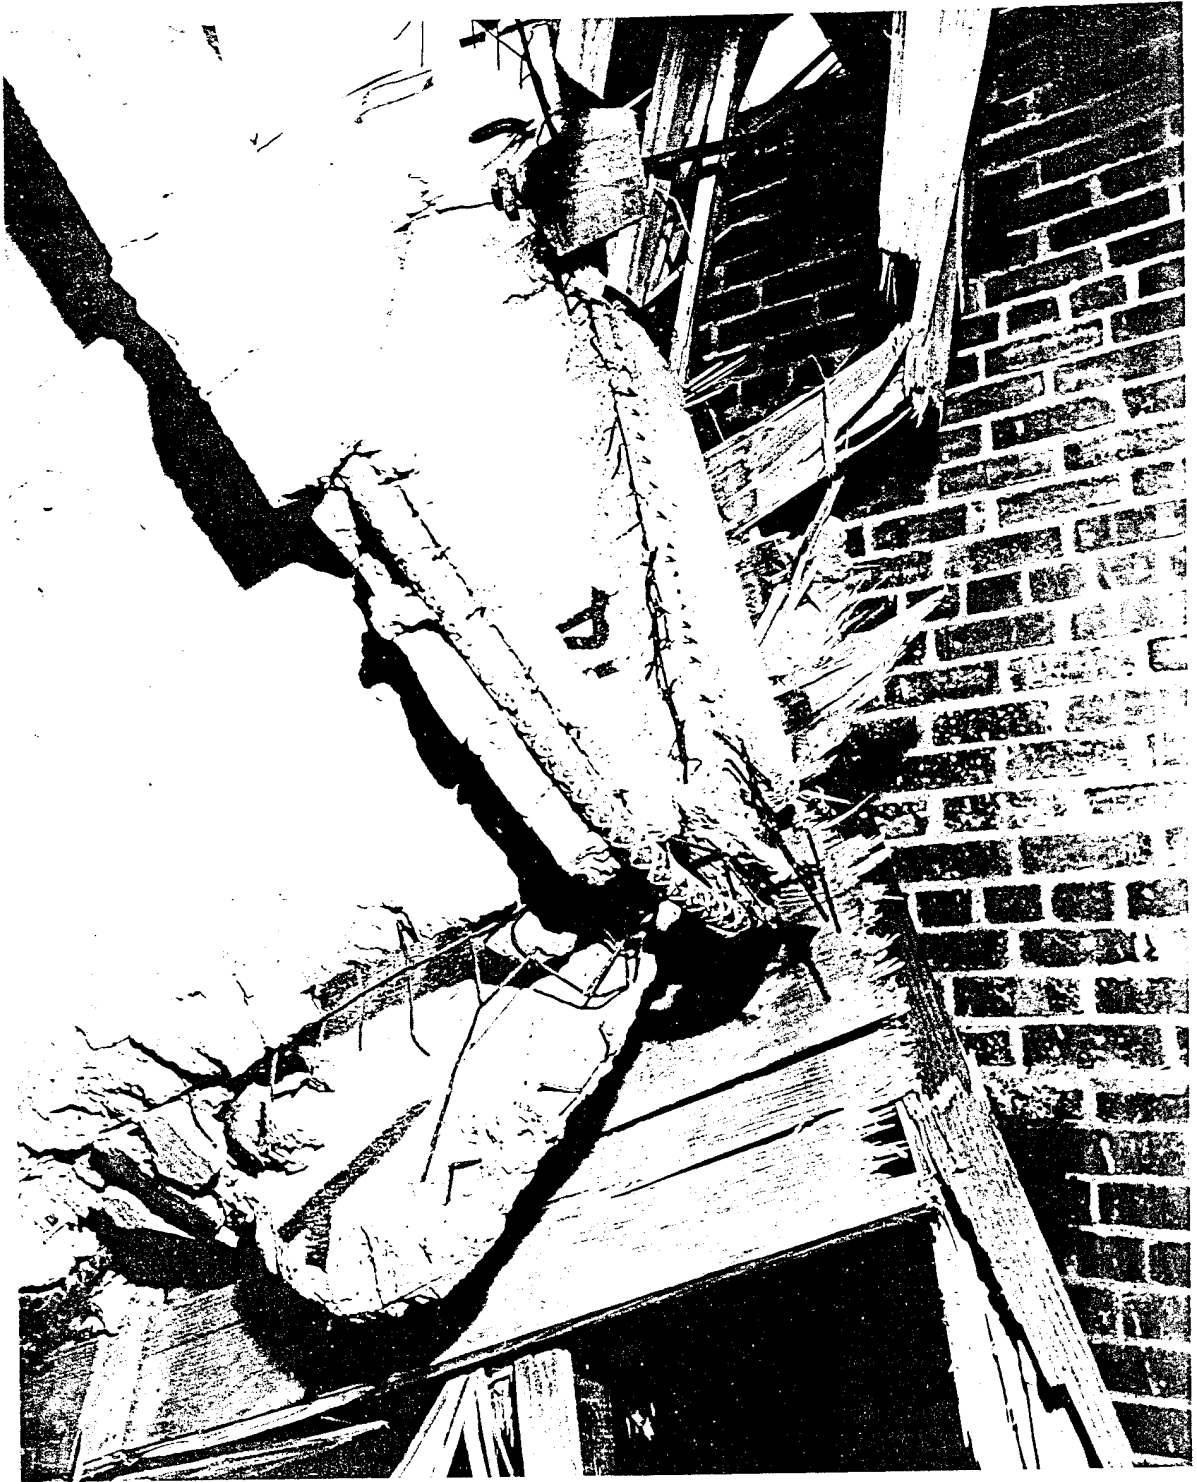
Fig. L.145 Detail of Fracture Point in Roof Panel, Structure 3.2.2b. Note where top steel has pulled out and sheared mesh at corner.

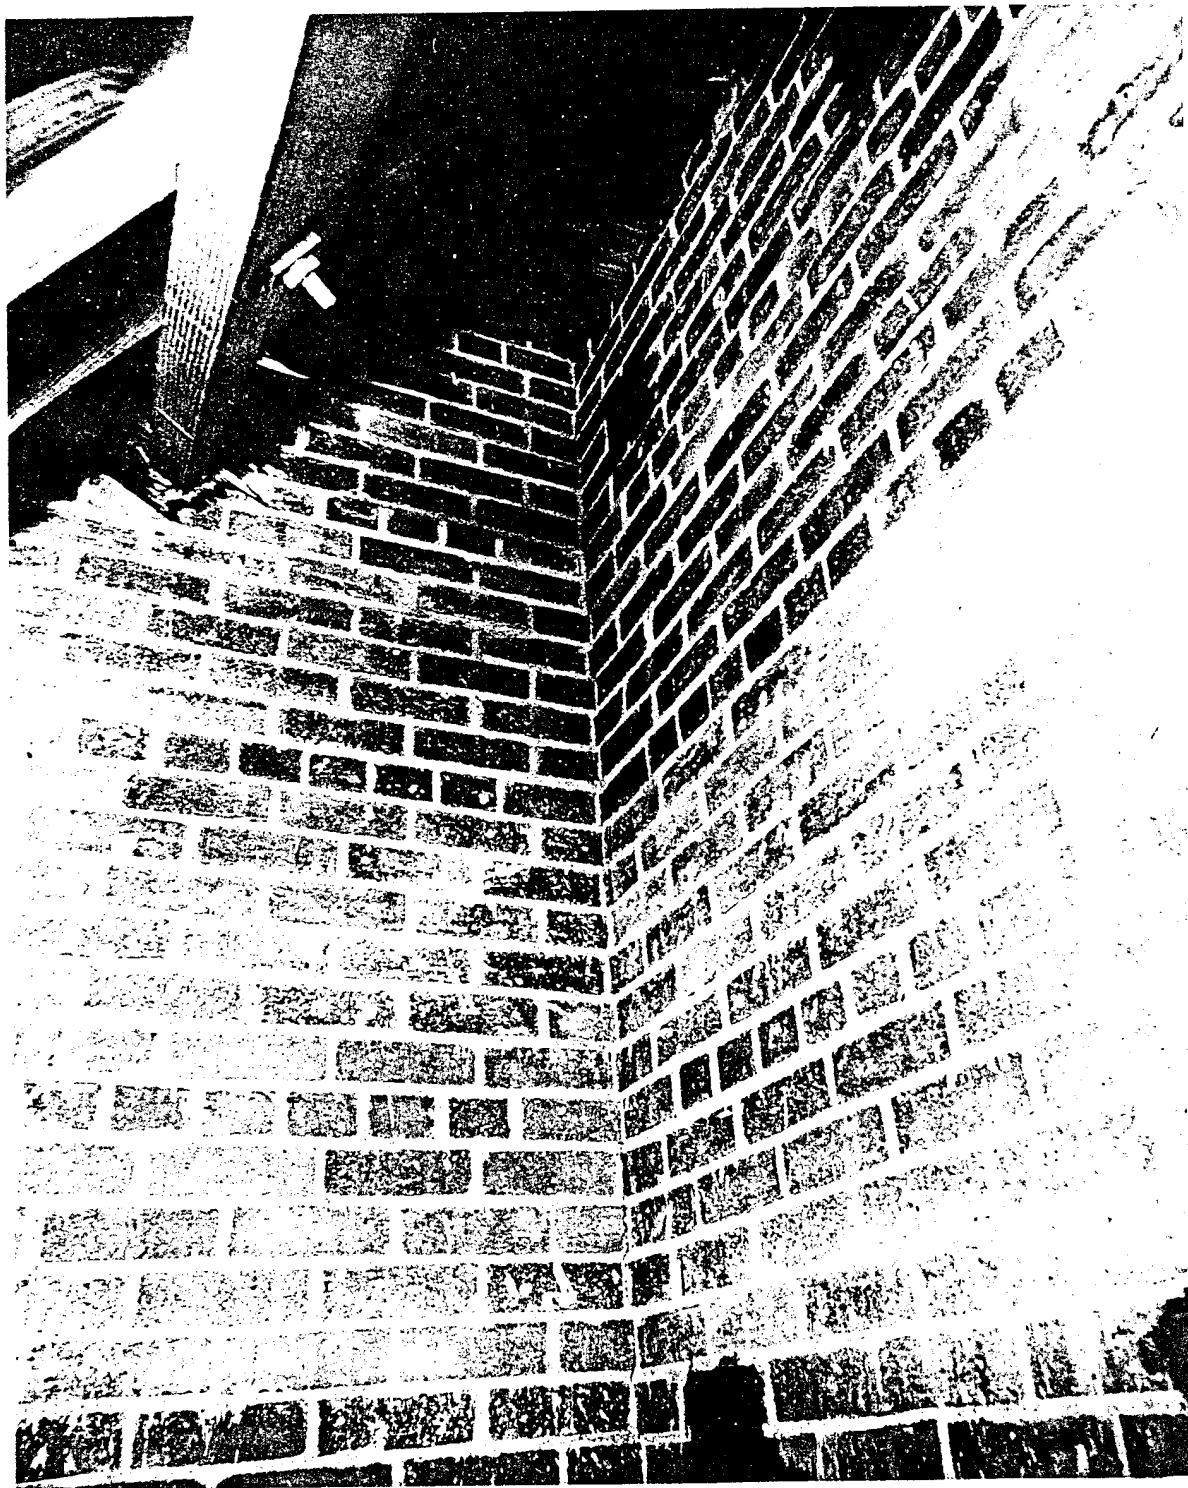
Fig. L.147 Crack in Brick at Left Rear Corner, Structure 3.2.2b

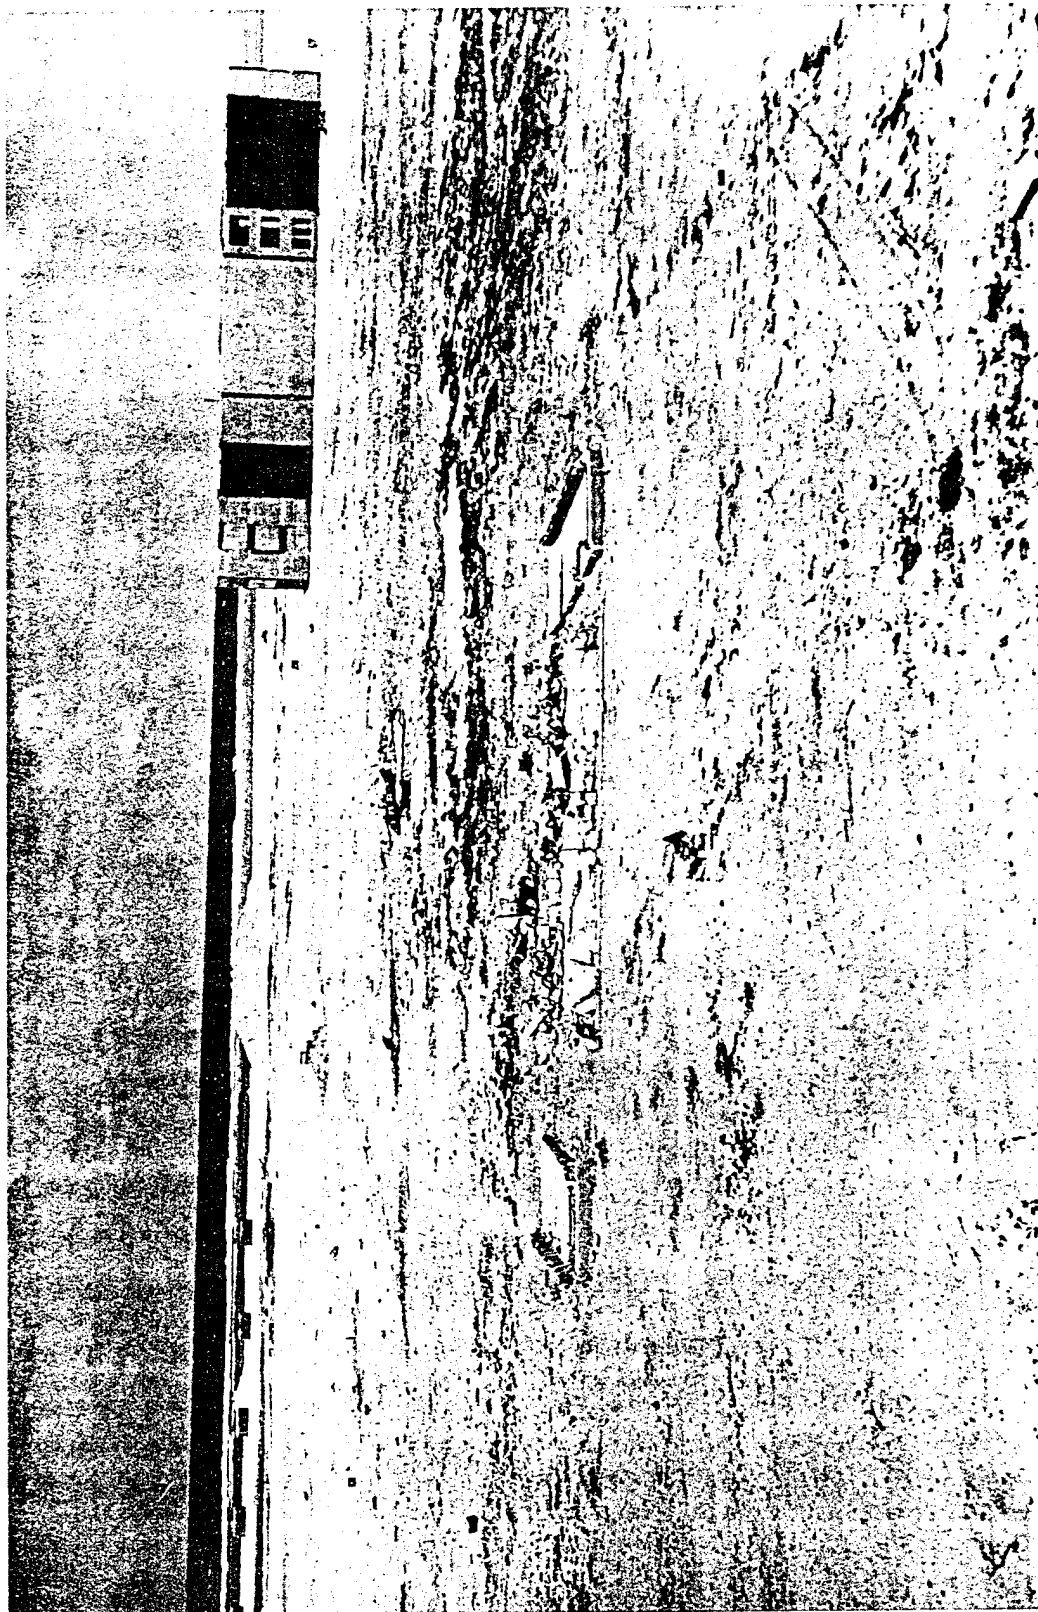
Fig. L.153 Aerial View Taken from In Front of Structure Location, Structure 3.2.3a. Note end walls lying to the right and to the left of the foundation. Sections of roof can be seen about 100 ft behind foundation.
